## Design and Planning of Riverbank Protection in Ledok Kulon Village, Bojonegoro

In Ledok Kulon Village, Bojonegoro, unstable riverbanks pose a direct threat to local infrastructure. Preliminary GEO5 assessments found existing slopes to be critically unsafe, with factors of safety consistently below 1.50 and hitting a dangerous 0.90 at section P3. To address this, a protection system was developed using soil investigations and numerical simulations. The design integrates gabions, Flat Concrete Sheet Piles (FCSP), and mini piles to withstand normal, flooding, and rapid drawdown conditions. Findings show that the rapid drawdown phase (C3) is the most critical for stability. Nevertheless, the FCSP components performed satisfactorily, maintaining structural integrity with a maximum displacement of only 14.6 mm. This design is technically sound and fully compliant with SNI 8460:2017 standards.

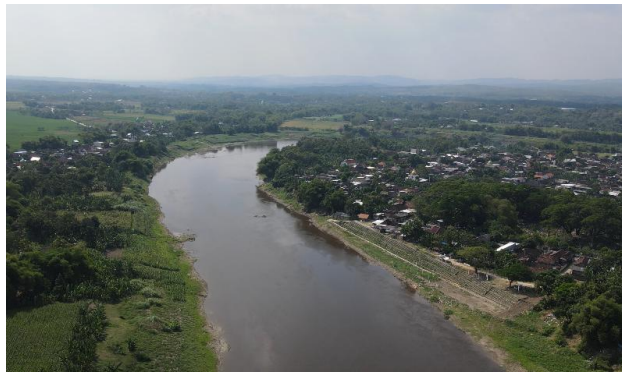
Figure 1. Drone Visualization of the Research Area

Riverbank stability is a critical concern for water infrastructure development. This challenge is particularly acute in regions like Bojonegoro, where extreme fluctuations in water levels create unstable conditions along riverbanks. In Ledok Kulon Village, the current state of the riverbanks shows a high vulnerability to slope failure. Initial assessments using the Bishop method confirm that the stability across the observed sections (P1 to P6) is critically low, with Factor of Safety (FoS) values failing to meet the minimum safety requirement of 1.50. This instability poses a direct threat to local settlements and infrastructure along the river's edge, necessitating an effective technical solution through the design of proper bank protection structures (Udomchai et al., 2018).

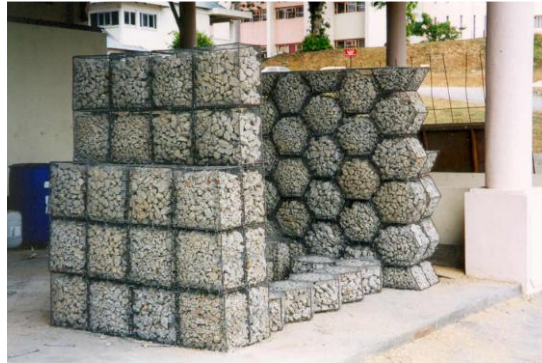
The application of hybrid structural systems that combine gravity-based retaining structures with foundation reinforcement has emerged as an effective solution for enhancing the global stability of complex slopes. Ramli et al. reported that gabion walls offer significant advantages owing to their structural flexibility and free-draining characteristics, which effectively reduce hydrostatic pressure behind the retaining structure (Ramli et al., 2013). In the context of riverbank stabilization, optimization of systems integrating gabion walls with embedded piles has demonstrated superior resistance to lateral shear forces compared with

Figure 3. Various Gabion Configurations Developed for Experimental Testing (Ramli et al., 2013)
